The Saale-Unstrut cultural landscape corridor

Abstract

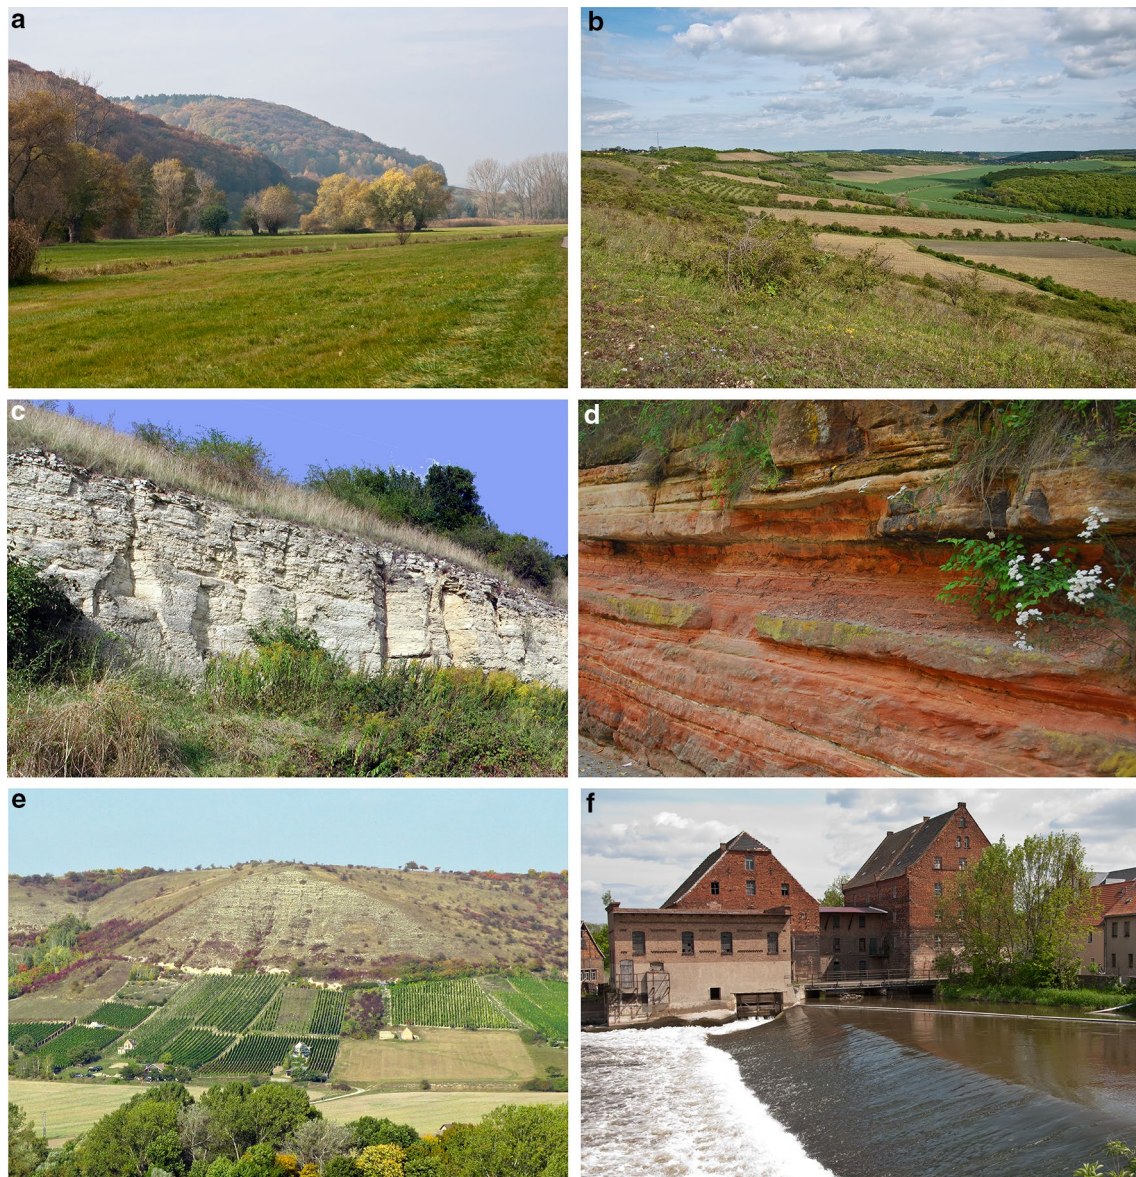
Fig. 2 Aspects of the relief, geology and viticulture and early industrial architecture of the Saale-Unstrut cultural landscape corridor. **a** Floodplain of the Unstrut near Zscheiplitz. **b** The old, pre- and interglacial valley of the Unstrut near Zscheiplitz. **c** Limestone outcrop near Zeddenbach (Lower Muschelkalk). **d** Middle Buntsandstein

outcrop in Schönbürg (Saale). **e** Vineyards at the location Nüssenberg (near Weischütz; above the vineyards dry grassland on Muschelkalk). **f** The Zeddenbach water mill near Freyburg, a monument of the industrial age around 1900

The current valley of the lower Unstrut was formed during the Drenthe stage of the Saale glaciation (300,000—130,000 years BP; cf. Fig. 2a, b). Today, the Unstrut

sector was still mentioned in a sixteenth century document (Schmidt 1934) and the village Flemmingen (Naumburg) is reminiscent of the Flemish. Not just in the name of the village, but also in its site complex, Flemish settlement activity is still identifiable (Schlesinger 1975). In the Early Modern Age, along with rapid development of technology, the number of documents describing the economic use of the river Unstrut increased. Water mills and weirs were constructed, the river was excavated, meanders were removed, tow-paths and locks were constructed. By the end of the eighteenth century, the river was a navigable waterway. This, of course, essentially changed the appearance of the river until today (Fig. 2f).

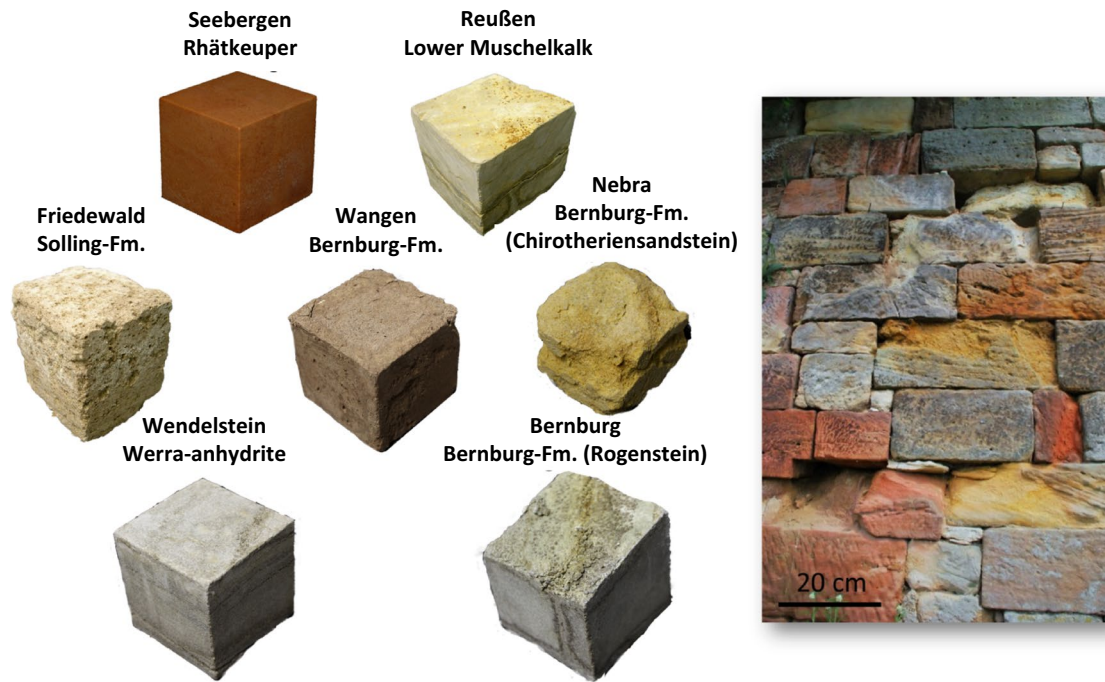
Fig. 4 Analysis of weathering phenomena. Left: artificially weathered building stone samples subjected to “salt splitting tests” by several cycles of soaking with sodium sulfate solution and subsequent drying. As also documented for stones in a wall section (right), resist-

ance against salt crystallization considerably differs among varieties of Buntsandstein rock. Except from Seebergen and Friedewald, all other localities are in the Saale/Unstrut area (cf. Stück et al. 2018)

until the end of the Triassic. Volcanic deposits and erosional products of the Variscan Mountains (Rotliegend) formed the initial stratigraphic units. Later on, transgressions and regressions resulted in alternating continental, fluvial, lacustrine and marine depositional environments and thus in a large variety of the resulting rock types. In the Saale-Unstrut area, the almost complete occurrence of the Germanic Triassic supergroup (Buntsandstein, Muschelkalk, Keuper; cf. Fig. 2c, d), including Zechstein (Upper Permian) manifest as outcrops in the area of the cultural landscape corridor (Müller et al. 2014). While all these rocks are important resources for dimension stone throughout Germany, long-term resistance to weathering of rocks from different strata is extremely variable (Stück et al. 2013, 2018, Fig. 4).

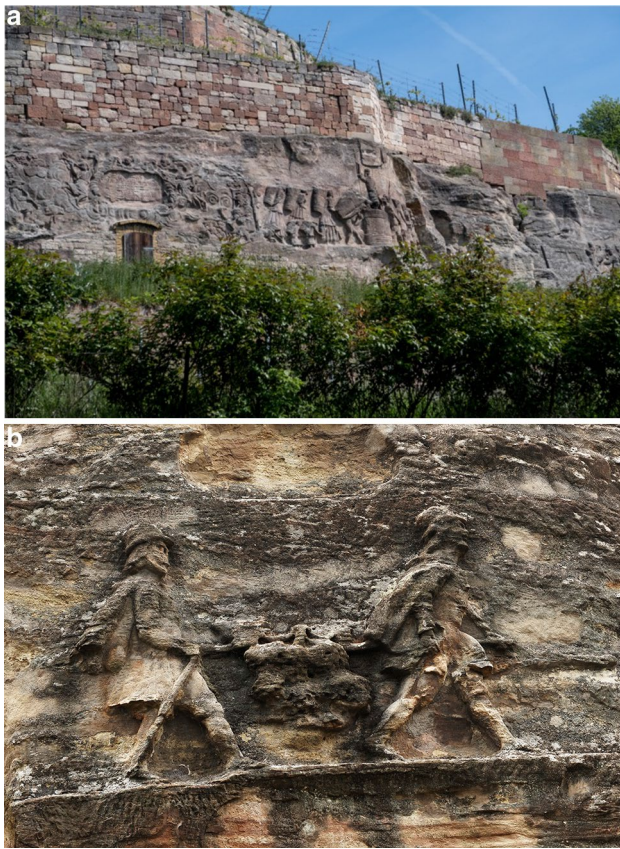
Fig. 5 The “Stone Album” (near Großjena) showing various weathering phenomena on the outcropping rock (Middle Buntsandstein). **a** overview, **b** small, heavily weathered section

II of Saxony-Weißenfels on horseback. The rock monument is exposed to severe weathering, and long-term preservation may be difficult (Wedekind 2014, Fig. 5).

This extraordinary monument is located directly at the Unstrut near Großjena. Despite progressive disintegration (Stück et al. 2018; Fig. 5), many details are still clearly visible, or have been reconstructed during past restoration efforts. However, reasons for progressive decay are not well understood and may in outcropping rocks differ from decay of building stone. Moisture, penetrating from the vineyard terrace above the monument is one possible reason for mobilization of salts (Wedekind 2014). Resulting salt burst may be the main cause for the reported surface disintegration. Recent monitoring and restoration measures started by the

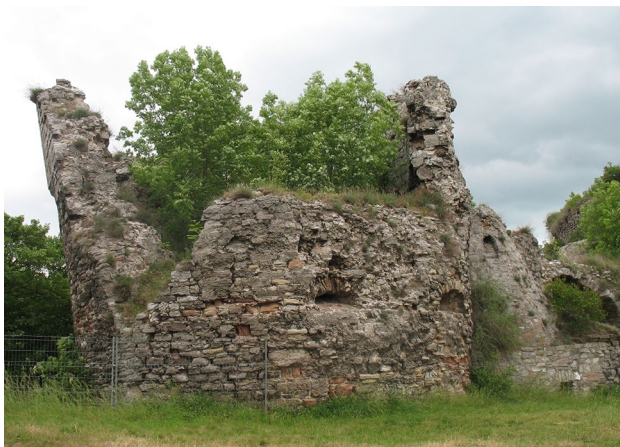
Fig. 6 Ruined tower of the Wendelstein castle (Memleben). Volume expansion of building stones upon uptake of water of the anhydrite causes inclination or bending of walls, but also refilling of existing clefts

At the Wendelstein rock, the bright, grayish-white Werra anhydrite (Zechstein series) rises over the valley of the Unstrut. The partially ruined Wendelstein castle, likewise consists of anhydrite, is situated at the hilltop above a river bend. Due to successive hydration of the anhydrous calcium sulfate and re-transformation to gypsum, along with substantial volume increase of the anhydrite the ruins show peculiar weathering phenomena (Fig. 6). Furthermore, intense karst phenomena are visible.

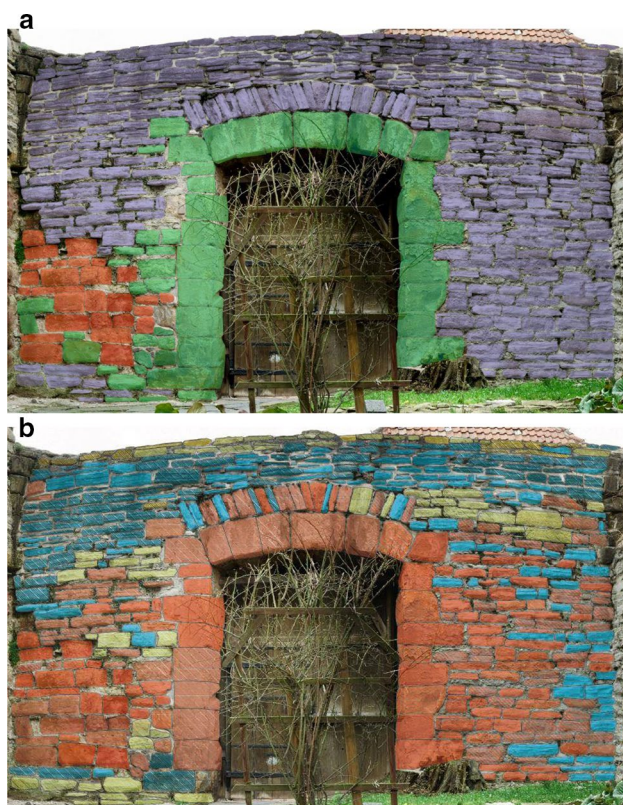
Fig. 8 Monastery Memleben, lithologies (**a**) and weathering phenomena (**b**) at a portal (cf. Stück et al. 2018). **a** Purple: Bernburg sandstone, green, red: sandstones taken from Middle Buntsandstein strata (green: Nebra sandstone). **b** Orange/red: formation of chips/scales; yellow: growth of lichens/algae; blue: backweathering

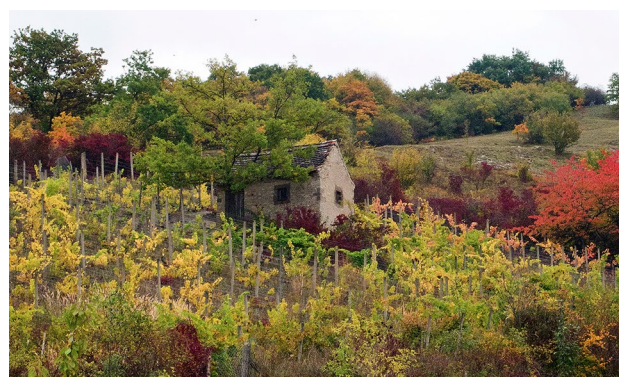
Fig. 9 The Kathert vineyard near Karsdorf with vineyard cabin and adjacent dry grassland and shrubs

A small modest cabin on the Kathert vineyard near Karsdorf is rather typical of its kind. With a ground area of approx. 4×6 m, walls of limestone rubble and a saddleback roof the cabin sits on a steep slope (Fig. 9). It is divided into a narrow vestibule and a main room. From the vestibule, a ladder provides access to a narrow attic. Both vestibule and attic provide storage space for farming tools. The main room was heatable.

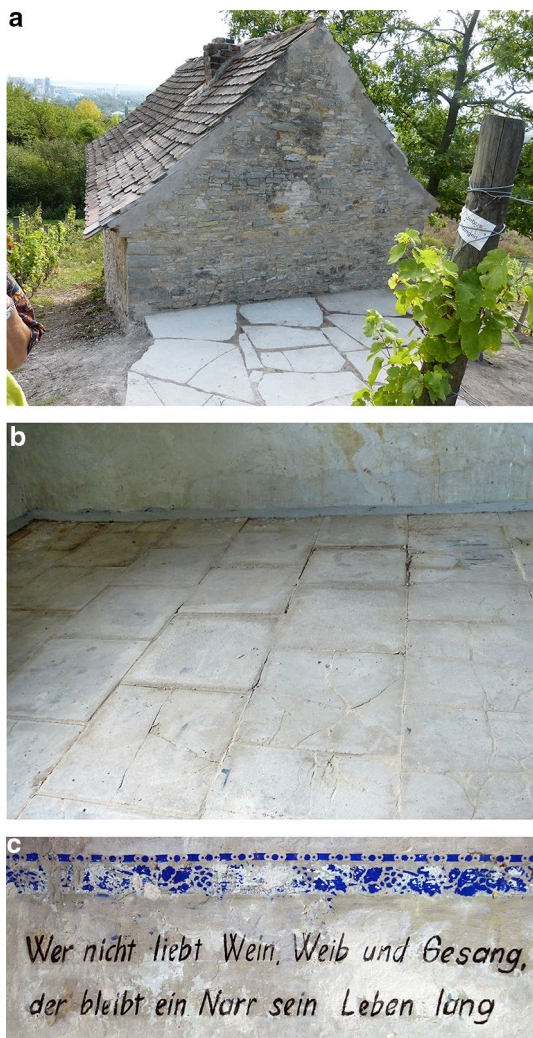
Fig. 10 Kathert's vineyard cabin after restoration. **a** Behind the cabin, limestone tiles for a small terrace were laid. **b** Restored floor tiles of the central room. **c** Wall section with banner

The cabin dates back to the first half of the past century. The plastered walls of the main room are decorated above the windows with circular stencil ornamentation. On the walls, in black letters, various aphorisms referring to viticulture were added in later times. Elaborate restoration would be inadequate for the unpretentious cabin, but the vineyard itself and its surroundings are representative of traditional viticulture in the cultural landscape (e.g., Bergmeier and Möhler 2014, see below). Although roof tiles were missing or broken and the mortar damaged, the construction as a whole was not affected. Restoration aimed at maintaining the status quo and improving the appearance of the interior (Fig. 10). To this effect, cracks were closed, and missing plaster areas were complemented with clay mortar. Detached areas of the distemper paint were glued onto the clay plaster with the aid of injected tylose (methyl cellulose) solution. Cyclododecane was used as a protective finish. The banners were supplemented. Sagged cement tiles of the floor were picked up, the floor was stabilized and the tiles re-laid. Torn tiles and joints were covered with a thin, fluid mortar. Missing shingles were replaced by traditional brick shingles. Backweathered mortar in the masonry was repaired with lime mortar.
